AIRCRAFT GROUND-FLOTATION INVESTIGATION

PART IV. DATA REPORT ON TEST SECTION 3

U. S. ARMY ENGINEER WATERWAYS EXPERIMENT STATION

TECHNICAL REPORT AFFDL-TR-66-43, PART IV

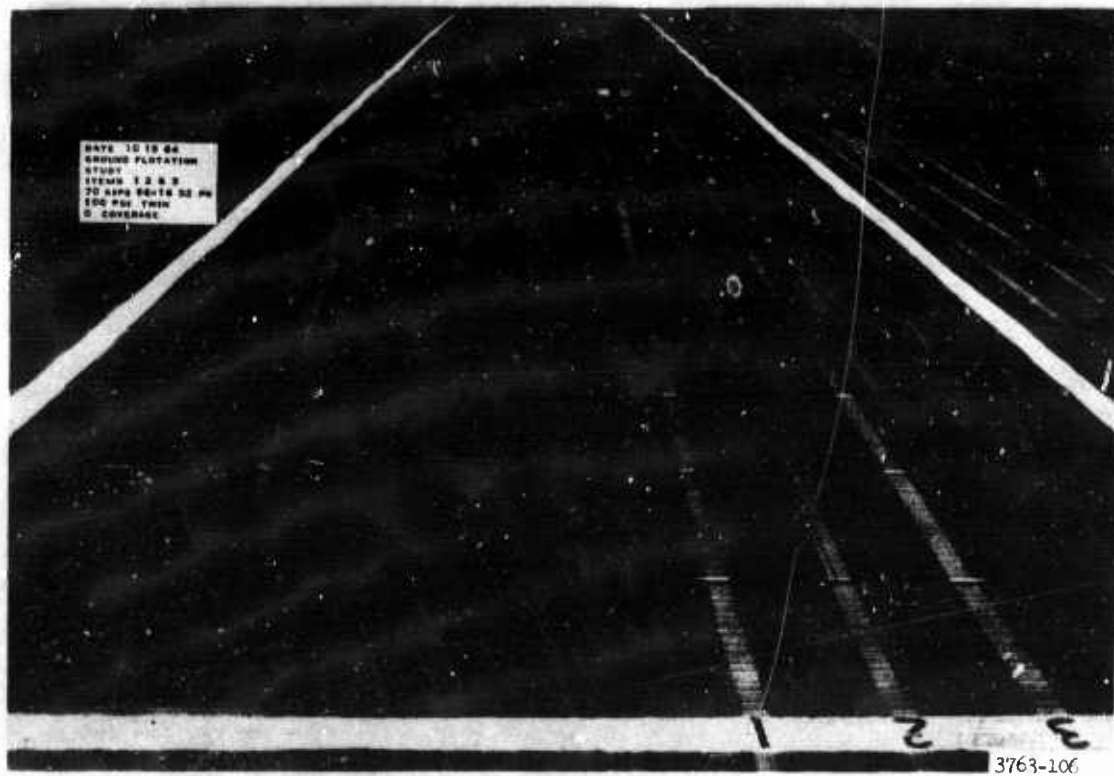
Figure 3. Lane 5, item 1, prior to traffic

Item 1. **Figure 3** shows item 1 (foreground) prior to traffic. Mat deterioration and subgrade deformation increased steadily with trafficking. The item was considered failed due to roughness at 28 coverages. A segment of the mat at the 30-coverage level after two post-failure coverages is shown in **Figure 4**. The rated CBR for the item was 2.0.

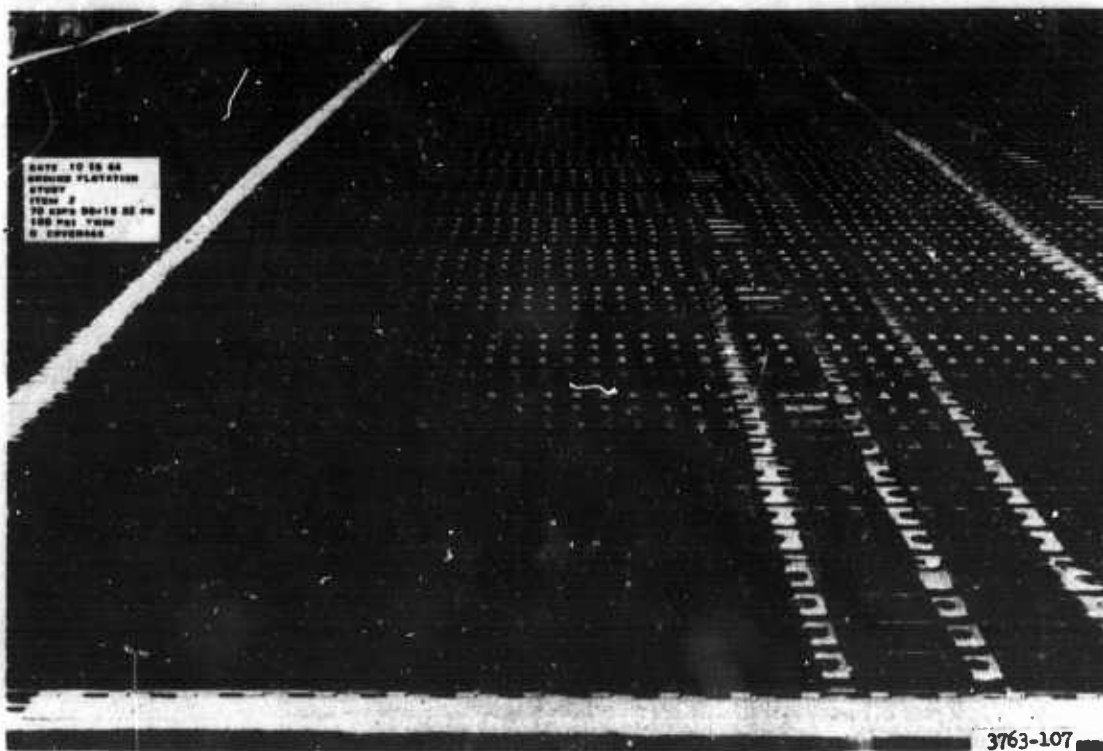
Figure 5. Lane 5, item 2, prior to traffic

Item 2. Item 2 prior to traffic is shown in **Figure 5**. The item was considered failed due to roughness at 28 coverages. Two postfailure coverages were applied. **Figure 6** shows the item at the 30-coverage level. As the item approached failure (28 coverages), the subgrade became less resistant to displacement and the resulting plastic deformation conformed to the impression made by the last pass of the tracking vehicle. The M8 steel landing mat was flexible enough to follow the contours of the deformed subgrade without breaking. The rated CBR for the item was 3.8.

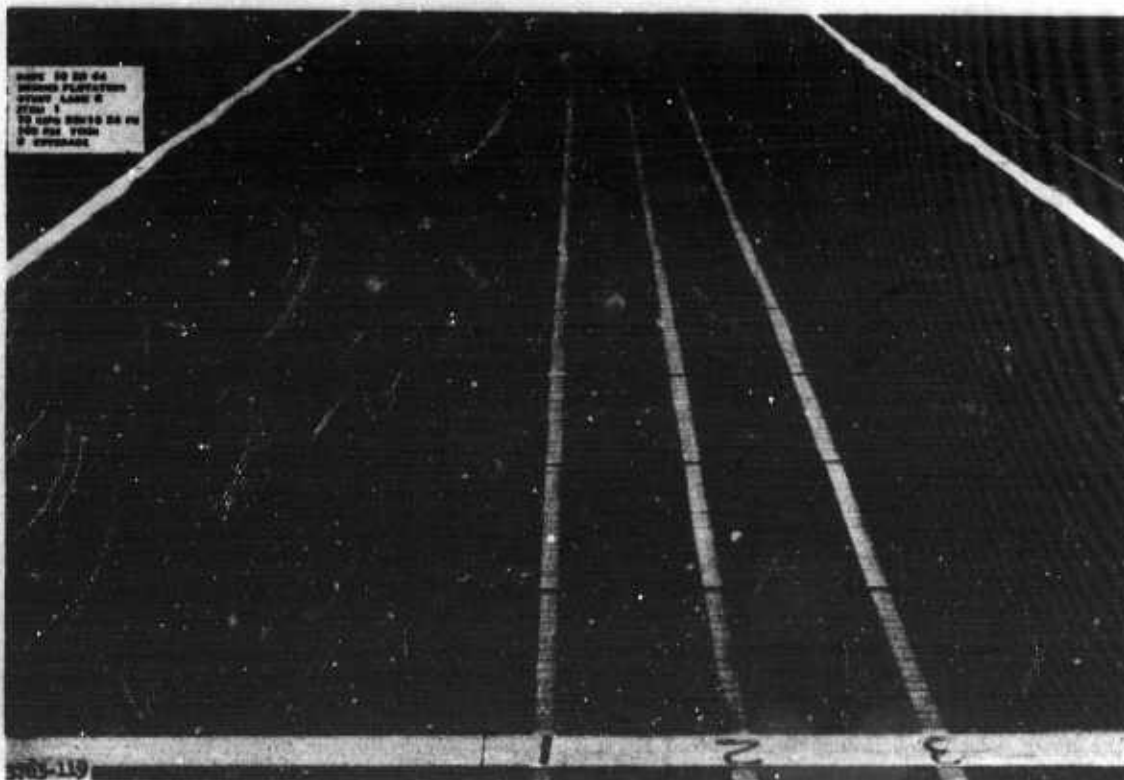
Figure 9. Lane 6, item 1, prior to traffic

Item 1. **Figure 9** shows item 1 prior to traffic. After the first 20 coverages, the rate of mat deterioration (breakage) increased. Displacement of the subgrade away from the center toward the outside of the traffic lane created a concave cross section. The item was considered failed due to roughness and mat deterioration at 130 traffic coverages. Traffic was continued to 156 coverages (**Figure 10**). The rated CBR was 2.0.
